SUN CARTRIDGE VALVES

Hex body & sleeve assembly integrity

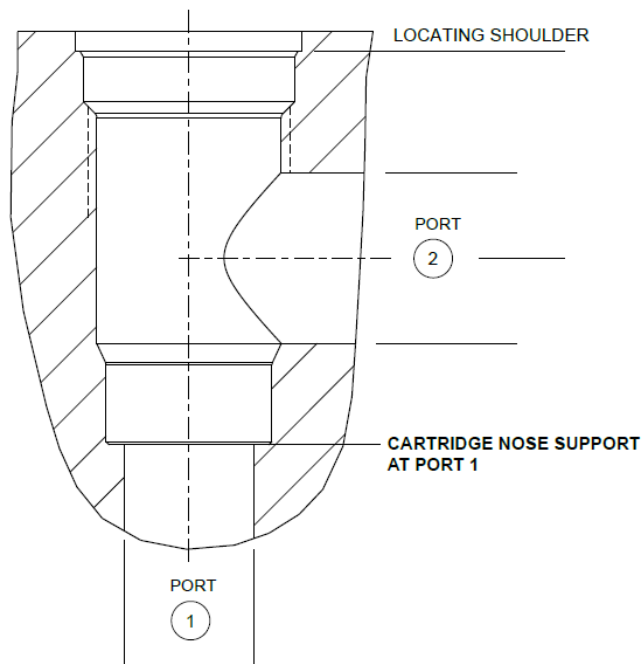
Fig. 1

With the use of this retaining ring, approximately 300 pounds of force (1330 N) is required to shear the retaining ring and separate the sleeve from the hex body. When properly installed in a correctly machined cavity, all loading against the retaining ring is removed, and the sleeve is supported by the port 1 cartridge nose support shoulder in the cavity (see fig. 1 below). Because of this design, any separation of the hex body and sleeve assembly during service can be traced to three typical causes:

- Cavity dimensional issues
- Lack of port 1 shoulder support
- Trapped pressure on port 2

In the event that the hex body and sleeve are separated during cartridge removal, it is important to inspect the cavity and cavity tooling to ensure manufacturing meets Sun specifications.
